Casio PG-300 MIDI guitar electrolytic capacitor replacement

(V 1.0 March 2007)

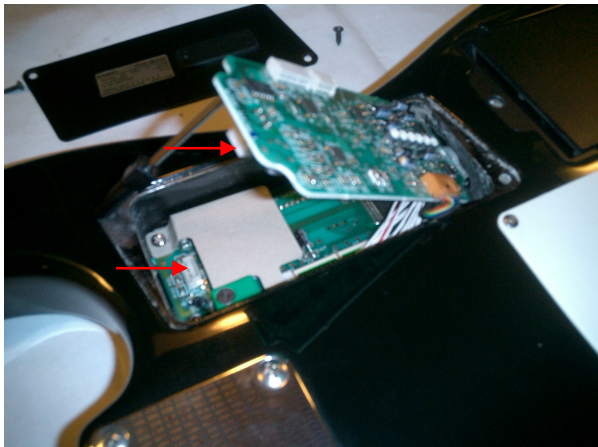
Figure 7c. Carefully lift off the top PCB (PCB1). Please note that there is an electrical connector between the top PCB and the bottom (marked by arrows). Also please note the small screwdriver holding the two PCBs apart.

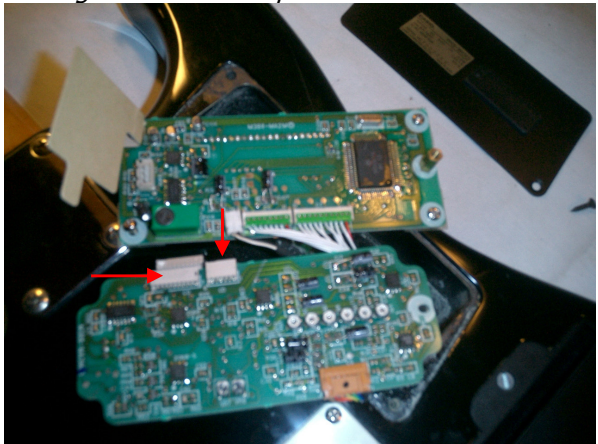
Figure 7e. Once separated, remove the electrical connectors (grey-coloured; arrowed) from the top PCB (PCB1). This can be done using the sharp-end tweezers to carefully separate the cables from the PCB1 connector.

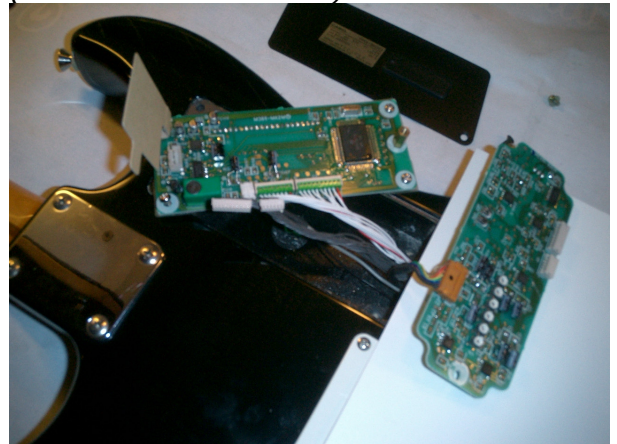
Figure 7f. Detach the final connector (orange-coloured) from the wiring, again using the sharp-ended tweezers. This should leave PCB1 free.
